Plastic Blow Moulded Bottles

Pulsed DC System

Plastics > rigid blow moulded bottles
> ISSUE 2

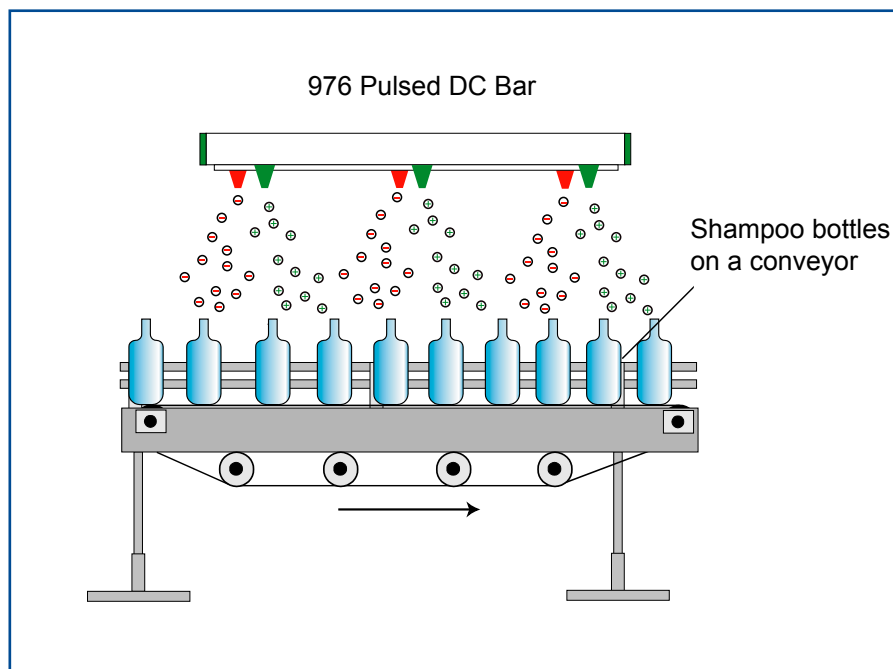
The positioning of a long range Model 976 Pulsed DC ionising bar as shown above resolves the problem.

Constant streams of ions neutralise the blow moulded bottles, the conveyor and the operators' bodies via their hands and arms which are regularly placed within the ionisation field.

The bars are typically mounted above the conveyor on a raised strip light gantry.
